Safety & Mission Assurance

Brad Weidema

8-2-22

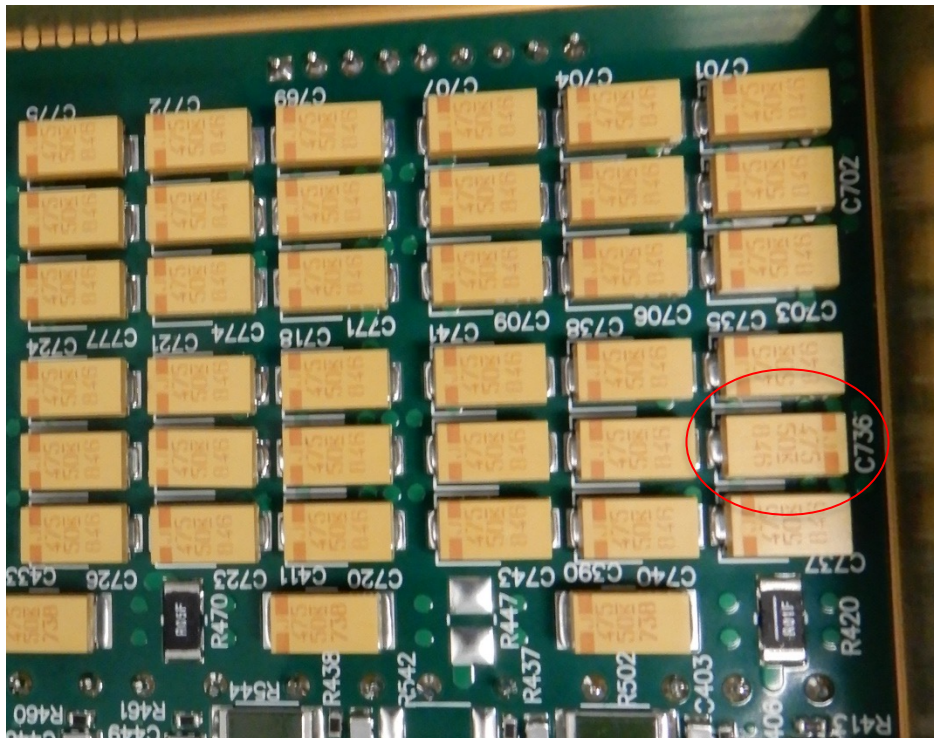
Photo before card power up

Reverse Polarity Capacitor Damage

- **Discrepancy:** capacitor was installed in reverse polarity, the card was powered up and incurred damage to the capacitor.

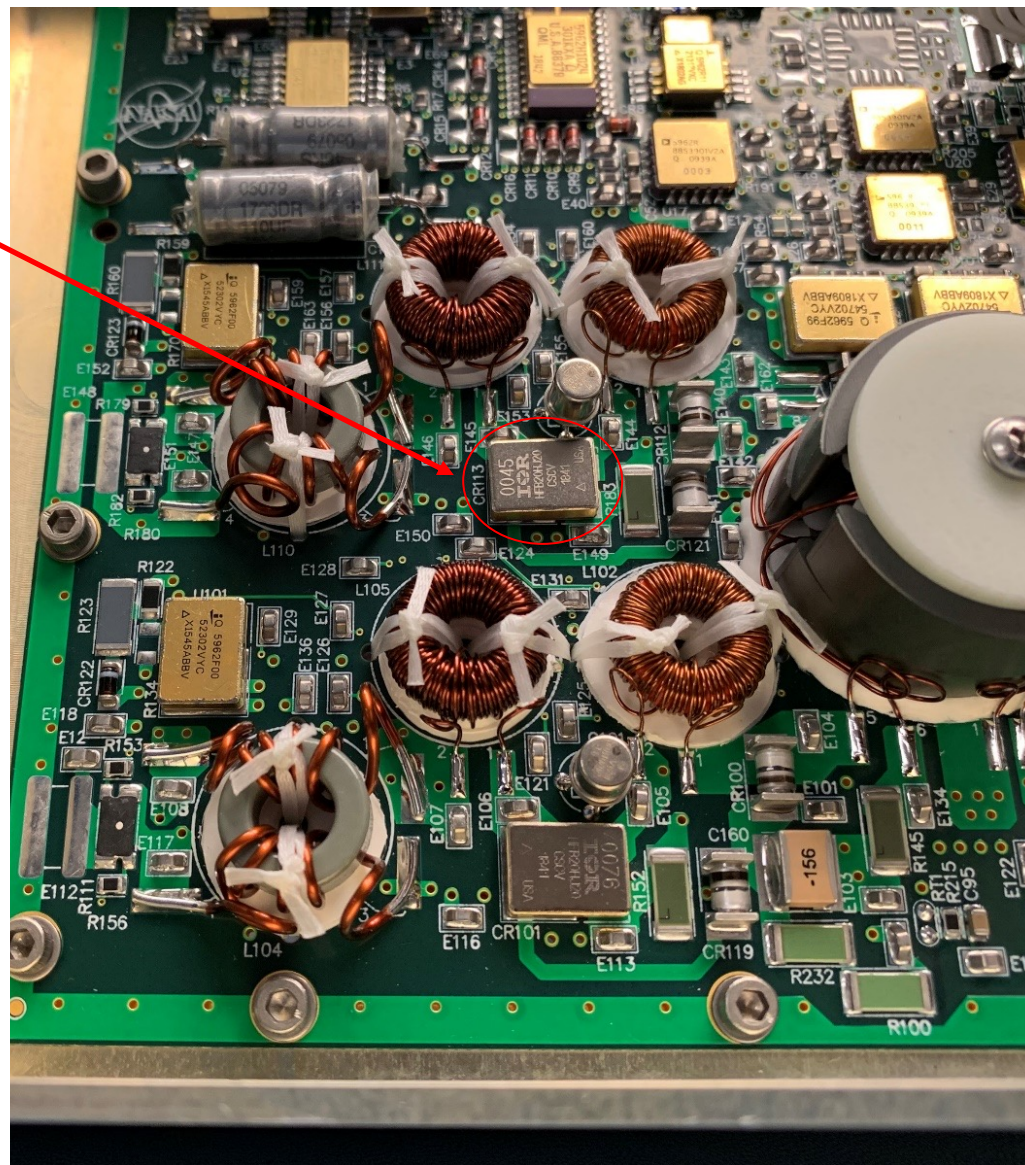
Reverse Polarity Diode

- **Discrepancy:** Diode was installed in reverse polarity.

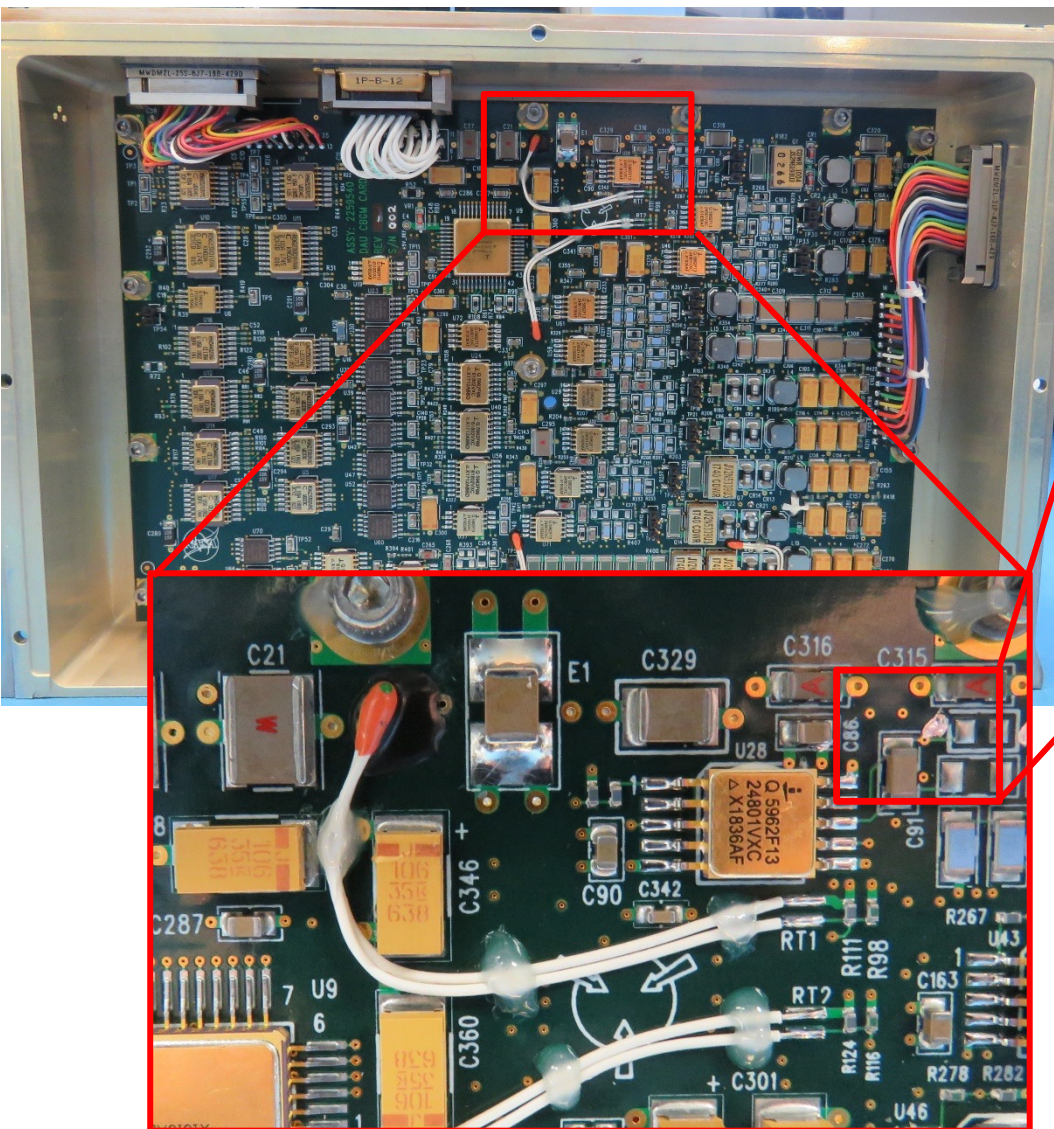
Solder Splash Bridging Conductive Vias After Rework

Solder Bridge was identified after rework
And functional testing, which revealed a failure

Solder splash occurred after a replaced nearby
Thermistor component (orange with white wires)

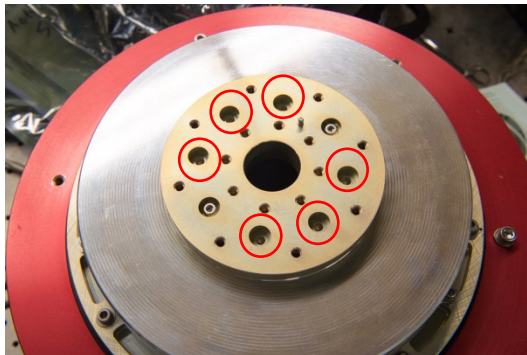
Discrepancy: Interface used to attach the Mass simulator to the spindle which in turn is holding the Motor was found to be attached with **only 2 "snugged"** fasteners during test. Missing other 6 fasteners and full torque.

Process Escape: Fit check steps not included in WOA. WOA steps calls for interface plate to spindle assembly – didn't do it b/c tech/engineer/QA thought it was already assembled, redlined this step out of the event WOA calls for torque values. But wasn't recorded, as tech thought it was already assembled and torqued in an earlier event (no earlier event calls for this)

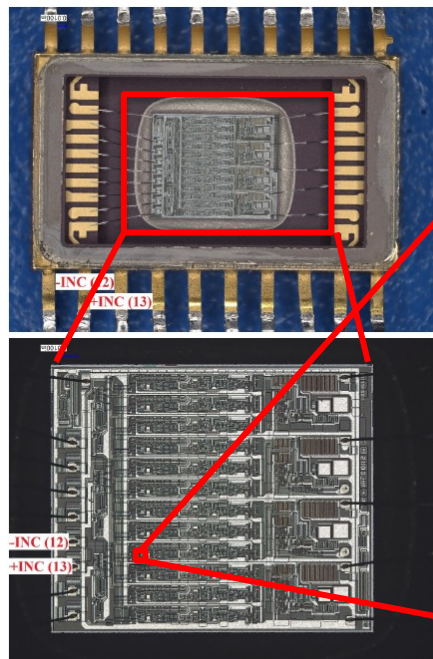
Figure 7. Optical images of SN 0537 after decapsulation. The INC signal pins are indicated.

The two pin holes on the right in the capacitor of the integrated circuit (IC) are indicative to ESD induced damage.

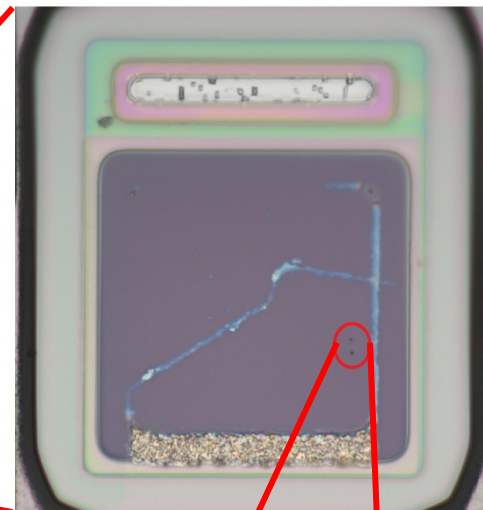
Figure 14. Optical image of the capacitor with much of the polysilicon chemically removed (some residual remains). The capacitor dielectric is exposed. The red oval indicates two pinholes in the dielectric layer.

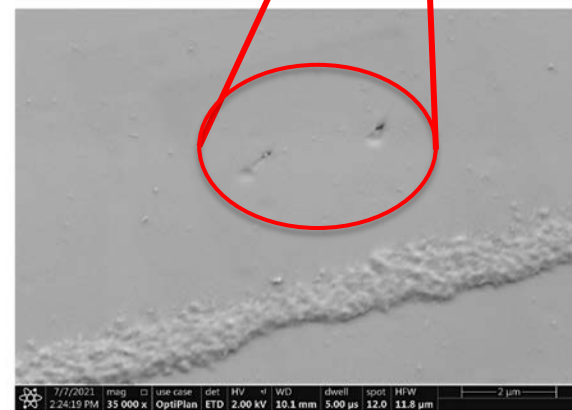
Figure 17. Tilted and rotated SEM image of the pinholes in the dielectric layer.

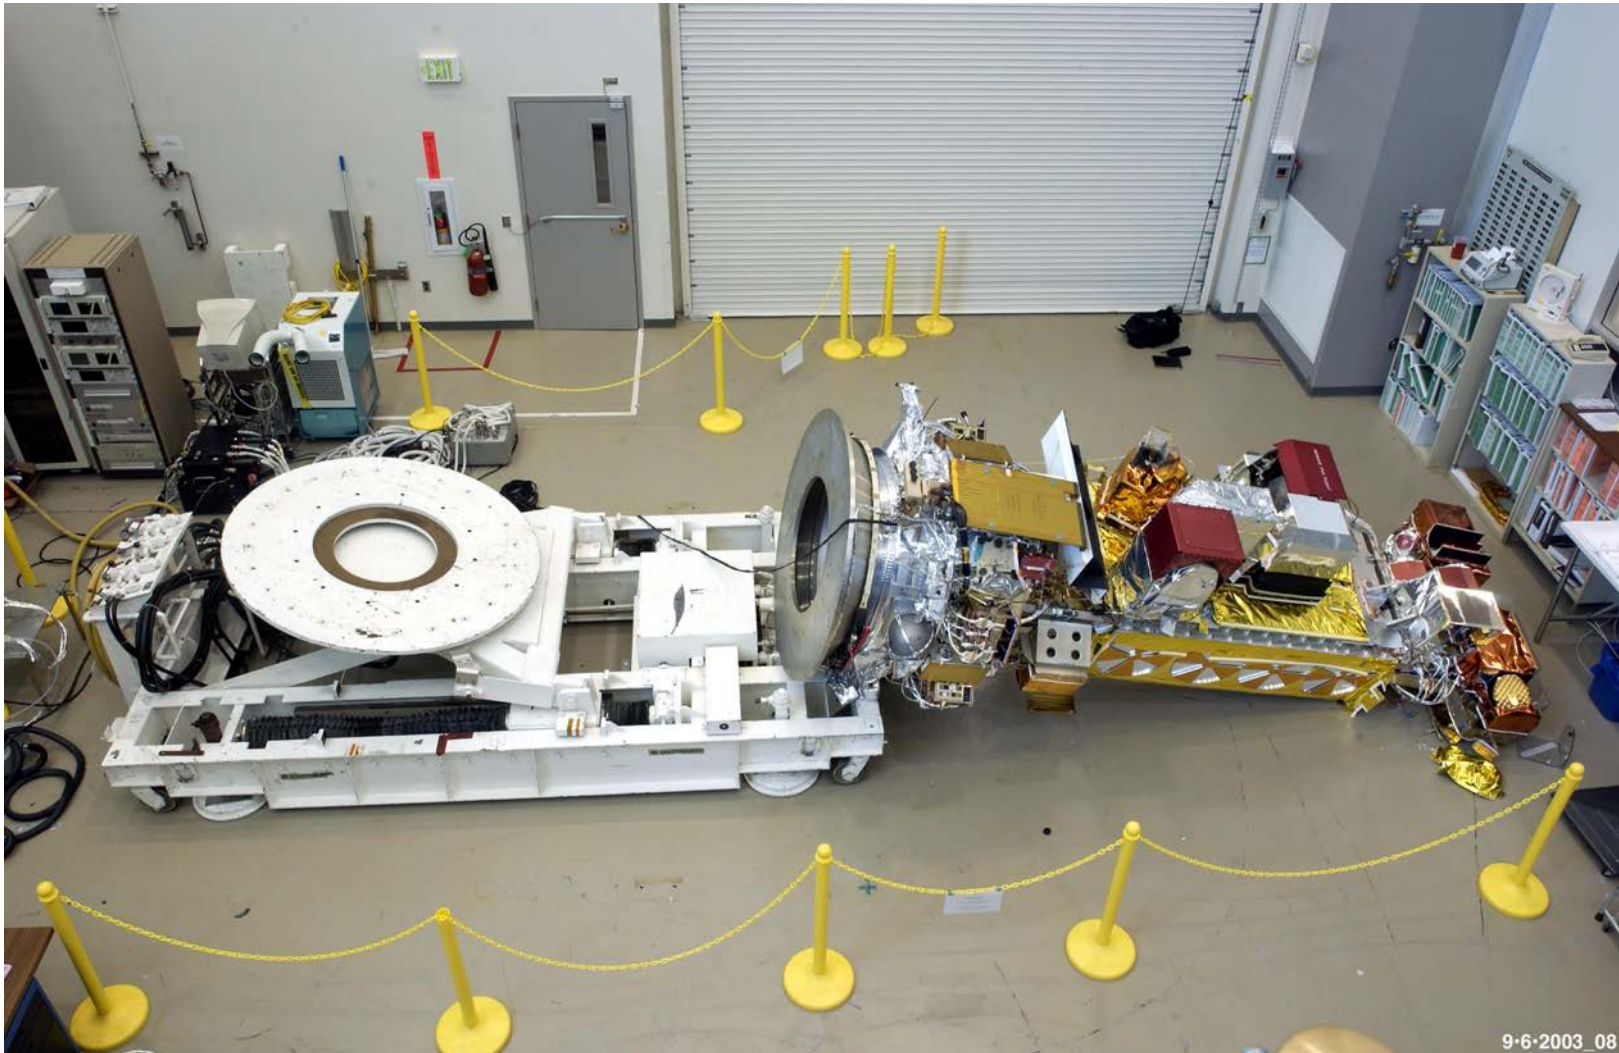
NOAA-19 Satellite Incident during I&T

- Cause: A result of process and procedural control deficiencies.
- Impact: \$135 Million in repairs
